Manhole Inspection Summary

Manhole # S19M__001MH

Insp Date: **3/26/08 10:01 AM**

Location Address: **2459 ashton st**

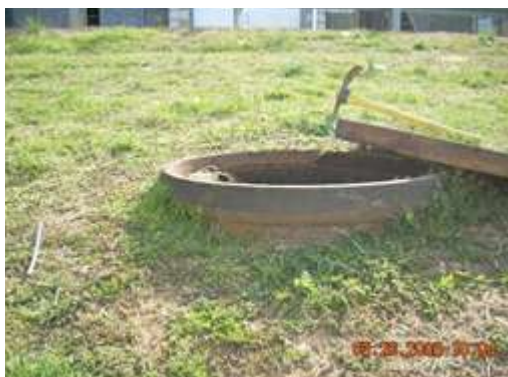
Defect 1

frame above grade

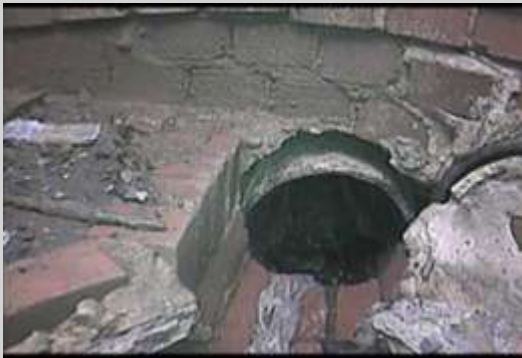
12 O'Clock Outflow

8 in. Circular Gravity Sewer
Pipe Out @ 12 O'Clock

Pipe Height: **7.2** (in.) Rod and Bar (Angled)
Pipe Material: **Clay** ☐ Pipe Lined
Invert Depth: **6.00** (ft.) Flow Characteristics: **Slow**
Deposits: ☒ None ☐ Mud ☐ Sludge ☐ Debris ☐ Grease
Silt Depth: **0** (in.) Deposits Extent:
Infiltration: **None** Pipe Seal Cond: **Broken**

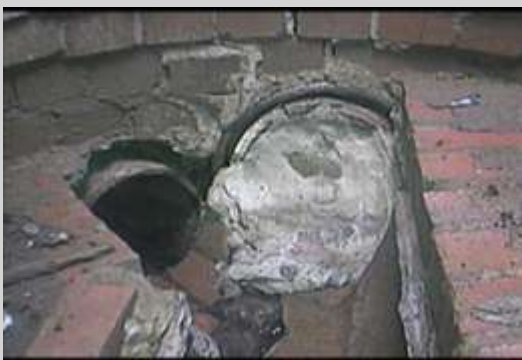
1 O'Clock Outflow

0 in. Circular Gravity Sewer
Pipe Out @ 1 O'Clock

Connects To: **Stub connection / abandoned**

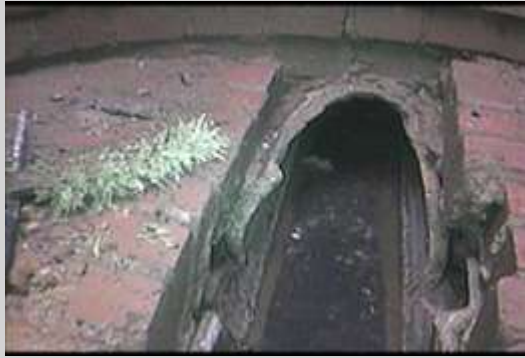
8 O'Clock Inflow

8 in. Circular Gravity Sewer
Pipe In @ 8 O'Clock
